## ASCE 41 Assessment of the Imperial County Services Building and Comparison with Recorded Response and Damage

D. Cook<sup>(1)</sup>, A. B. Liel<sup>(2)</sup>

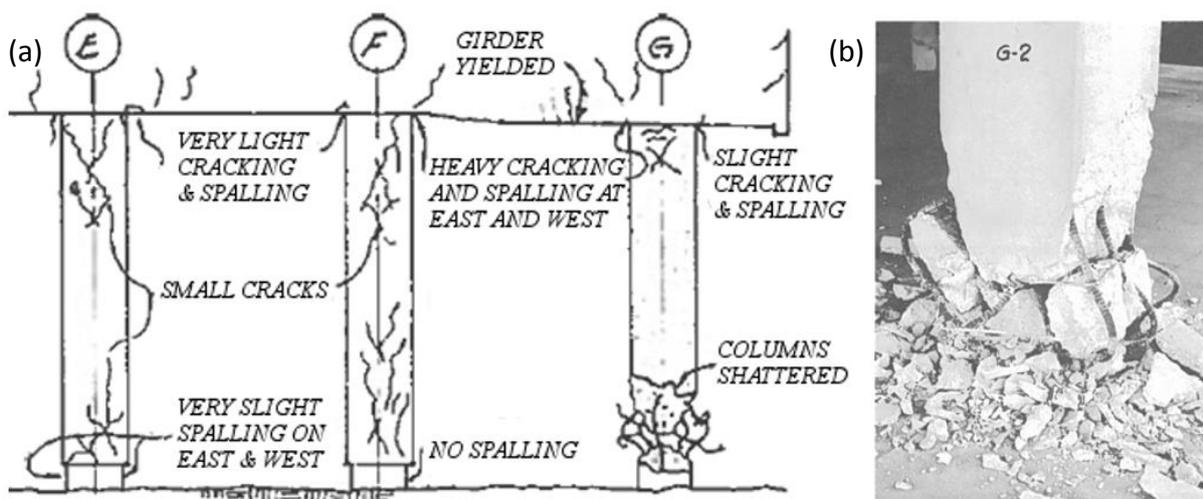
A number of reports documented damage to this building [15,16,17]. The building sustained significant damage to the first-story columns, especially on the eastern-most frame line (column line G), as shown in Figure 3. This eastern column line exhibited axial column failure above the ground slab where spacing transverse reinforcement was wider, likely following shear failure. Interior columns' damage in the first story consisted of shear cracks primarily associated with response in the E-W direction. First-story walls

showed some cracking. After the earthquake, the building was demolished due to the failure of the east-side columns.

Figure 3 – Illustrations of damage showing: (a) detailed damage description of frame line 1 at the first story; heavy shear cracking and minor spalling is apparent at the base of the first-story columns; (b) damage to columns on grid line G resulting in 9 in. of shortening of eastern-most bay (diagram and picture from [16]).

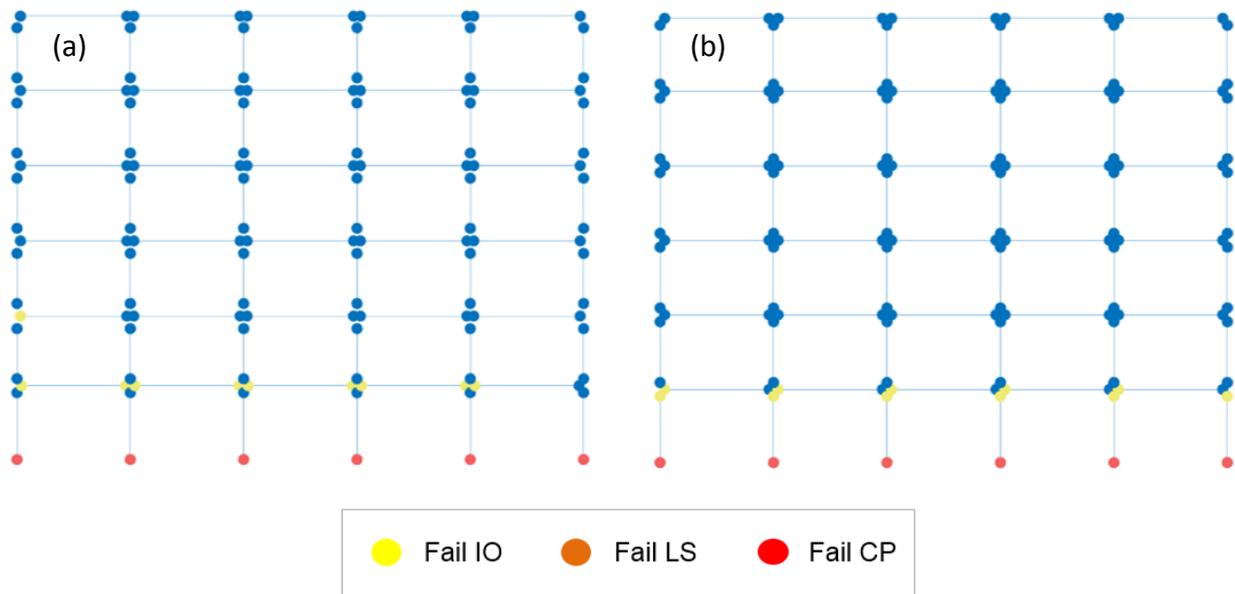
The distribution of damage over the height of the building is illustrated by comparison to ASCE 41-17 acceptance criteria in Figure 7. The model predicts that the columns fail CP at the base of the first-story columns, and IO at the top of some of the first-story columns, effectively creating a pinned-base response. Post-earthquake reconnaissance reported little to no damage in the upper stories, and the model response is consistent with these reports. The model predicts that most of the beams did not yield, although the second-floor beams failed the IO acceptance criteria. Damage surveys found only minor cracking in beams throughout the building. No damage was reported to joints in any of the available damage surveys, and no damage to joints was indicated by the analysis.

Figure 7 - Assessment of column and beam response relative to ASCE 41-17 nonlinear acceptance criteria for (a) exterior frame line 1 and (b) interior frame line 2.

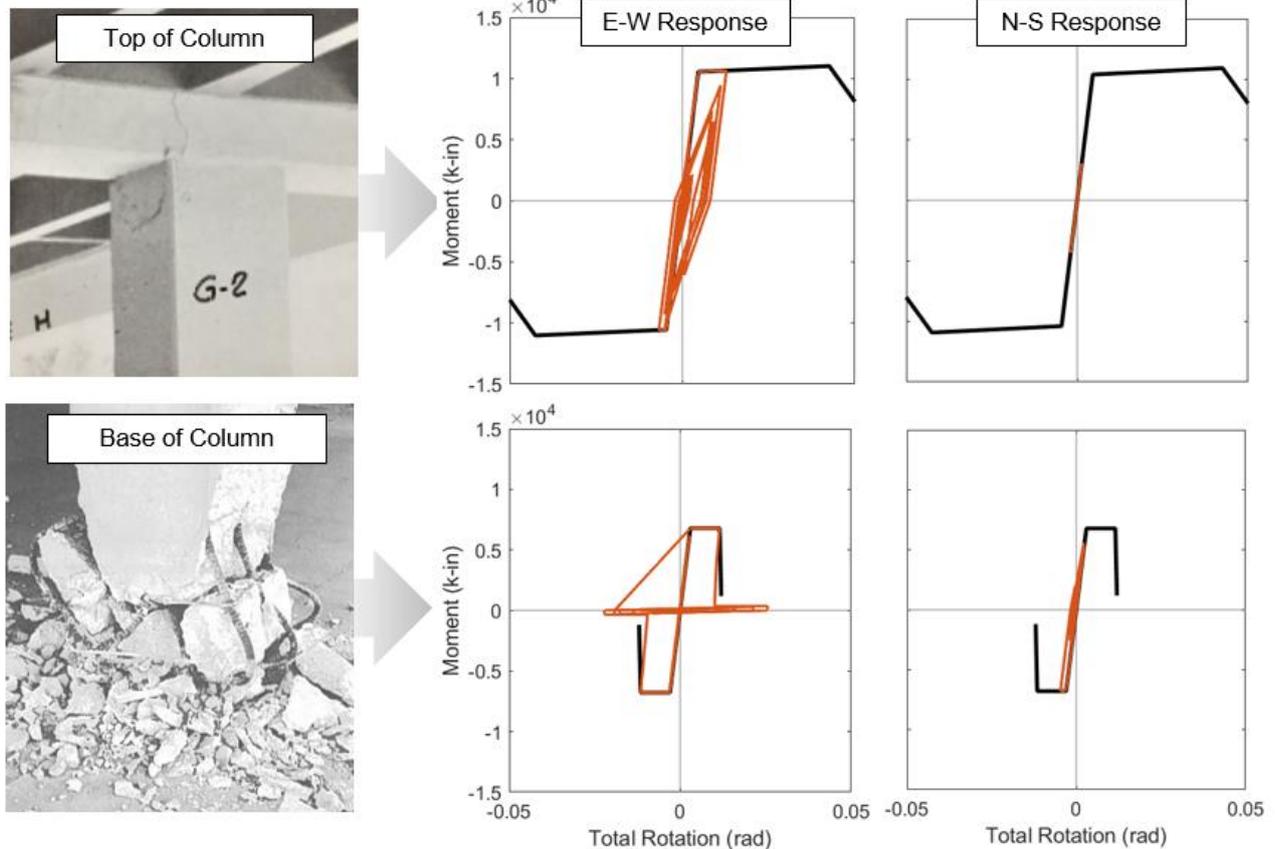
The response of the exterior first-story column G-2 is examined in more detail in Figure 8. These results show that, at the column base, the modeled column has lost practically all of its strength and stiffness, especially in the E-W direction. At the top of the column, however, where transverse reinforcement spacing is much narrower (2 – 3 in.), the columns have just reached their flexural capacity in the model in the E-W direction. These results seem qualitatively consistent with the damage photos, which showed limited flexural cracking at the tops of the columns. The model predicts the least ductile behavior and response most beyond the total rotation capacity (point E on Figure 4a) at the base of the columns on the eastern-most column line, due to the higher axial loads and consistent with observations of damage. The model response also indicates that all columns have exceeded their total rotation capacity and lost gravity-load bearing capacity, according to the definition of the ASCE 41 backbones. However, the observed damage would indicate that only the eastern most columns have lost gravity-load bearing. This would imply that the ASCE 41 damage assessment of the first story columns is conservative for most columns other than the eastern-most columns.

Figure 8 - Damage photos from [16] of column G-2, with model backbones and hysteretic response in the recorded ground motion. Total rotation of each hinge is defined as the sum of the elastic rotation of half of the column and the plastic rotation of the hinge.
