CRITICAL STRUCTURAL WEAKNESSES EXPOSED IN OLDER RC WALL-FRAME STRUCTURES DURING THE CHRISTCHURCH EARTHQUAKES

Abstract

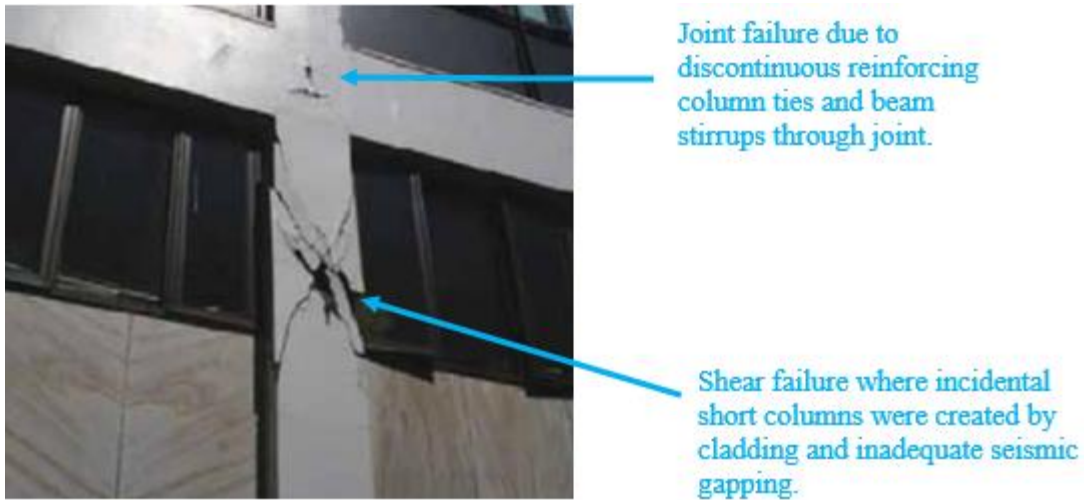
The perimeter frames sustained heavy damage, particularly at the beam column joints. In addition, there was significant cracking and spalling to columns on the northern perimeter (see Fig. 4) [10]. The engineer that assessed the damages suggested that the structure appeared to have “twisted vigorously” around the shear core, leading to perimeter frame damage; the engineer believed the building to be near collapse. In addition, the building had developed a lean towards the south-west, which would suggest differential settlement of the foundation, and made salvaging the structure impractical [10].

Fig. 4 shows an image of typical column shear failure on the north side of the structure. The shear failure happened as a result of the contact between the column and the cladding when extreme torsion caused excessive displacements at the perimeter farthest from the center of rigidity [2]. Shear failure in the columns suggests that there was inadequate detailing at the point where the column made contact with the cladding panels. Along with the column shear failure, the image also shows joint failure above the column. Joint failure suggests inadequate detailing through the beam-column connection.

Fig. 4 - Column and joint damage on north side of Securities House. Source: [2], and annotated by authors.

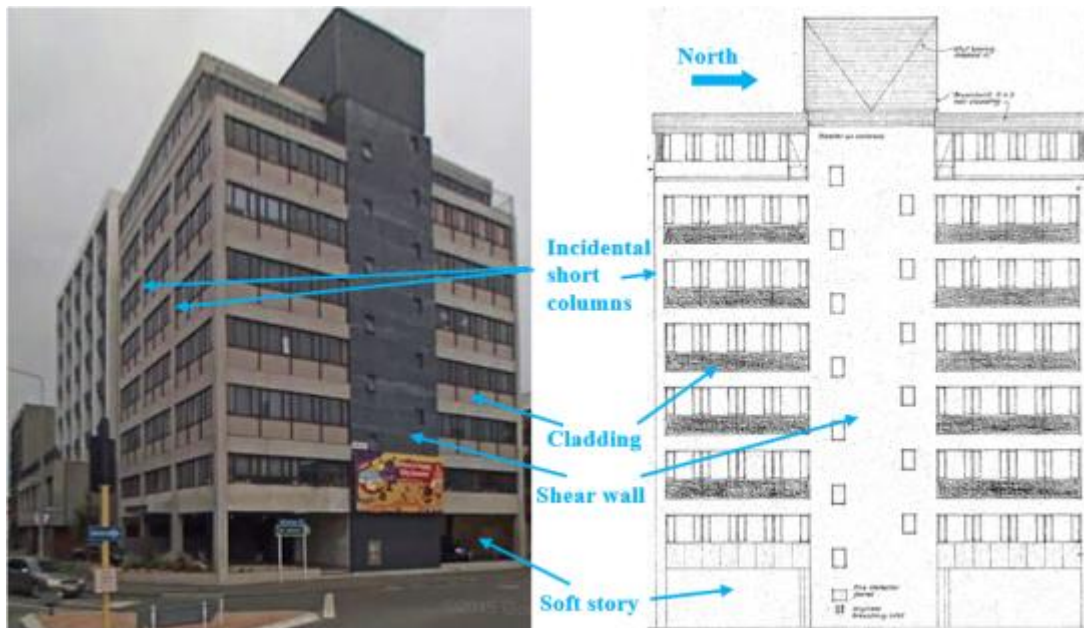
Securities House has an apparent soft-story vertical stiffness irregularity (G6, following the CSW numbering scheme in Table 2) at the first level, which is evident in Fig. 5. The columns at the 1st story are taller than the upper level columns and in addition the entire ground level is open, which makes this a CSW because of the vertical discontinuity in stiffness and, likely, strength. It would take detailed strength calculations based on the member detailing in the plans to confirm this, but qualitative engineering judgment can easily identify this weakness.

Fig. 5 - Elevation of the Securities House. Sources: left image google maps, right image building plans [15], annotated by the authors.

The damage evidence suggests that short columns were incidentally created at the perimeter, due to contact with cladding due to inadequate seismic gap between the cladding and the column [2]. Referring back to Fig. 5, it can be ascertained from both the physical building and the building plans that cladding is prevalent throughout the height of the structure. Furthermore, the cladding is inset flush with the exterior, essentially sandwiched between the columns. The consequence of this configuration is that when the displacements of the building are large enough, contact between cladding and column is possible, changing the moment and shear demand on the columns [2]. In addition, Fig. 8 has a typical perimeter column reinforcing plan detail which shows that there was not additional reinforcement detailing specified which would allow for this contact. In short, Securities House has a (G7) CSW because there is cladding between the columns.

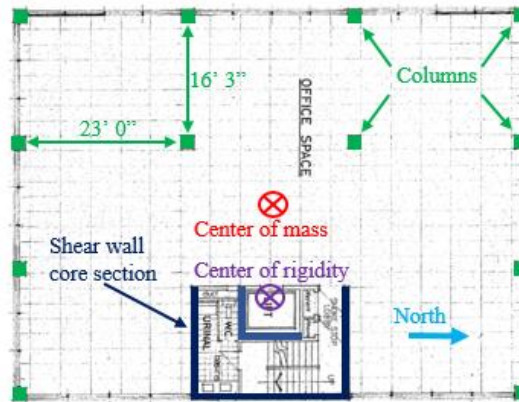
A common (G1) CSW exhibited by many of the most severely damaged Christchurch buildings is torsional eccentricity caused by nonsymmetrical wall layout. The shear wall core of Securities House is located to the far east of the building as indicated in Fig. 6. Reasonable engineering judgment locates the center of stiffness offset from the center of mass, because of nonsymmetrical wall layout in one direction. During a

seismic event, rotation of mass around the center of rigidity will lead to the largest displacements at the north and west walls [13]. This conclusion comes as no surprise and is supported by the Level 2 damage report which states that the building appeared to have “twisted vigorously” around the shear core and that most of the column damage was on the north and west side [10].

The core section is not quite square, but does not qualify for a G2 CSW (narrow core). Since the configuration of the core section is a C then there is only a single wall in the North-South direction to resolve the lateral force. Furthermore, despite the inherent ability for the beam-columns connections to resist moment forces, the single shear wall is the primary lateral force resisting system for the entire structure in one direction. This is the definition of a non-redundant system and leads to the identification of a non-redundant G3 CSW for this structure.

Fig. 6 - Plan view of Securities House. Source: Building plans [15], annotated by the authors.

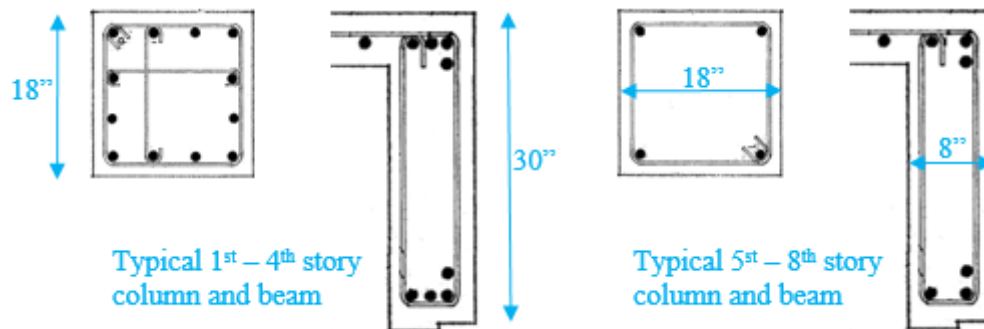
Evidence supporting the claim that the deformation capacity of the columns is not sufficient to resist large lateral displacements is prevalent in many of the specific details of the columns, beams, and beam-column connections. By comparing typical beam column size throughout the structure, as provided in Fig. 7, the beams are clearly very deep compared to the height of the column. Also, comparing the quantity of rebar in the beams and columns suggests that columns are likely the weakest link without more detailed calculation (L3 CSW).

Fig. 7 - Typical beam and column configuration at lower and upper levels, showing likely failure of columns preceding beams. Source: Building plans [15], annotated by authors.

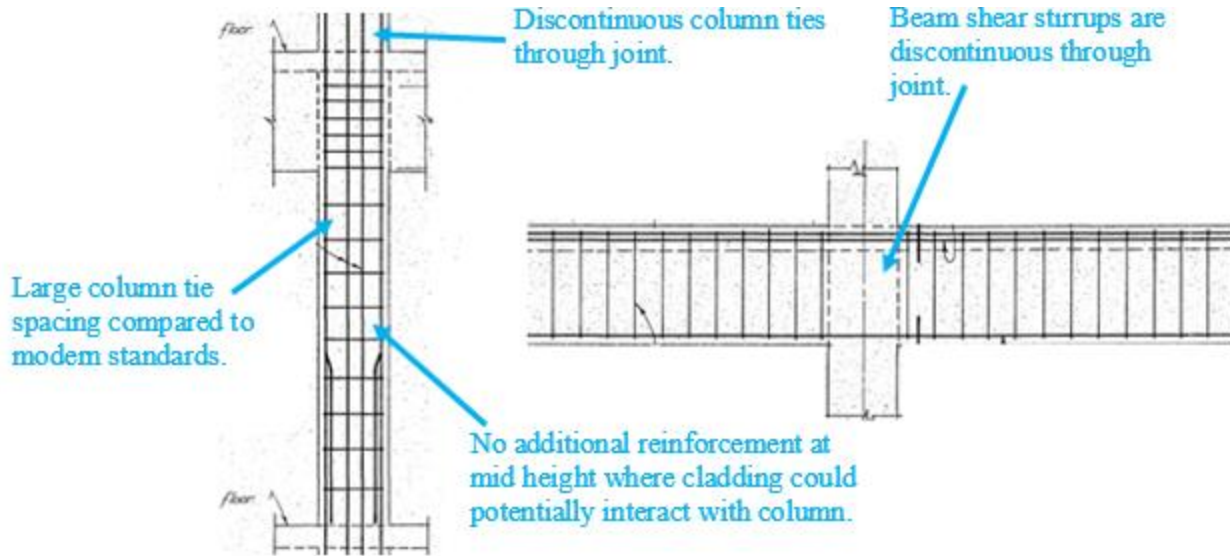
Fig. 8 - Inadequate tie and stirrup spacing in columns and at joints. Source: Building plans [15], annotated by the authors.

Fig. 8 also shows us that the column tie detailing is inadequate because of large spacing compared to modern detailing standards. This is typical of older concrete structures, but also a dangerous L4 CSW because it allows the possibility of shear failure in the columns. In addition, Fig. 8 also shows that both the beam stirrups and column ties are discontinuous through the joints. Modern detailing requires joints to be much stronger than the beams or columns, and also requires confinement of the joints [14]. Confinement would be difficult to achieve without sufficient reinforcing, and the lack of confinement/continuous reinforcing through the joints is considered a (L5) CSW.

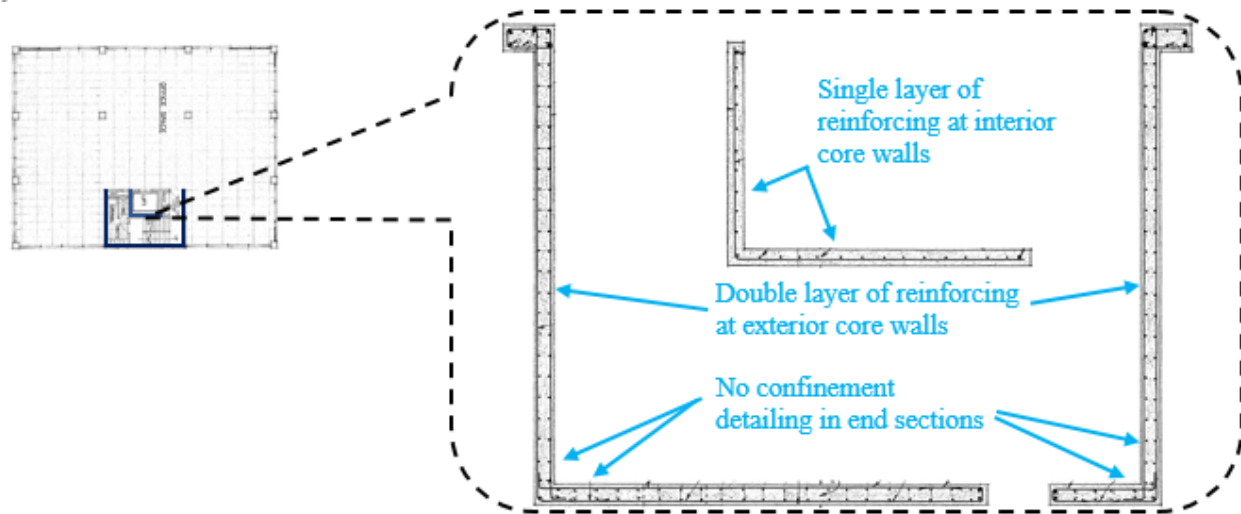
Modern shear walls would generally have additional confinement rebar specified for end “boundary” sections. The Fig. 9 detail is the core section for Securities House. This image and the elevation detailing images which are not included in this paper all show that there is no special detailing for boundary confinement. The lack of detailing is a L2 CSW because lightly reinforced walls have been shown to buckle. Fig. 9 also emphasizes that there is a bit of subjectivity required in the decision making about CSWs. In this case, the external core section has a double layer of reinforcement, while the inner core section has a single layer of reinforcement. The single layer would be considered a L1 CSW and the double layer would not. Since we neglected the inner core in our assessment of a redundant system then it seems appropriate to neglect it here as well, assuming it is not a critical part of the lateral force resisting system.

Fig. 9 - Reinforcement detailing in wall core section, shown with respect to location on the building plan view.
Source: Building plans [15], annotated by the authors.
